November 03, 2006

Digital Ink Lines on a SMART Board[™] 600 Series Interactive Whiteboard Appear Jagged When a SMART USB Audio System is Attached

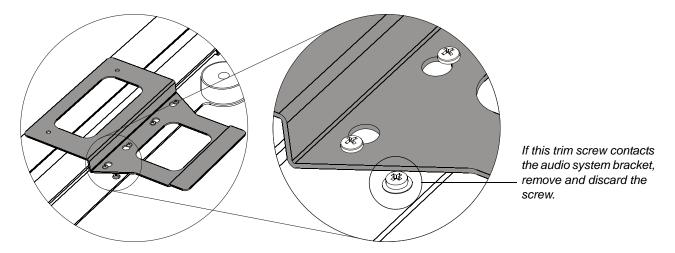
Digital ink written on a SMART Board 600 series interactive whiteboard may appear jagged. This can be the result of electrical interference caused by the metal brackets used to mount the SMART USB Audio System to the rear of the interactive whiteboard.

If the brackets contact a trim screw on the rear of the interactive whiteboard, electrical interference can occur.

Remove the trim screw below the USB Audio System mounting bracket on each side of the interactive whiteboard and check if the interference disappears. You can also disconnect the power adapter from the audio system to see if the interference disappears. If either of these tests eliminate interference, proceed to the solution below.

If the trim screw on either side of the interactive whiteboard contacts the audio system mounting bracket, remove and discard the trim screw. These two trim screws aren't necessary for the interactive whiteboard's reliable and safe performance.
